# Varus / Valgus

# With Your® Liner

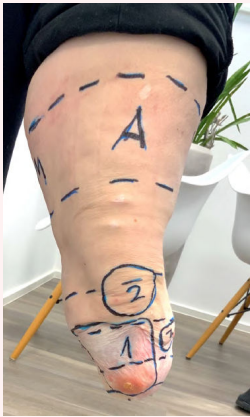
Example 1

The distal segment of the residual limb is mis-aligned with the load bearing axis of the leg. The below-knee segment of the stump is pointing inwards or outwards.

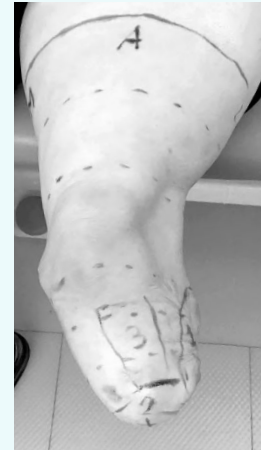
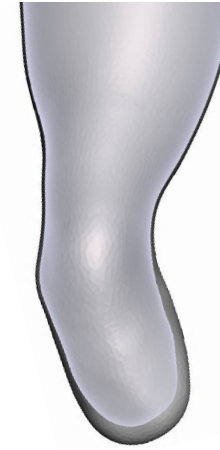
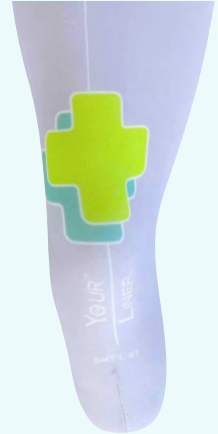
With its custom shape and adapted compressions, Your® Liner provides a close fit and adequate compressions all over the limb, eliminating the issue of excessive pressure, friction, air pockets and pinching of the skin.

The customisable thicknesses also allow to properly cushion sensitive areas, which can otherwise be exposed with absence of localised cushioning and overstretching of the external face
